Aircraft Materials Report 123

**ION VAPOUR DEPOSITED (IVD) ALUMINIUM COATINGS FOR THE  
CORROSION PROTECTION OF HIGH STRENGTH STEEL**

**B.R.W. HINTON AND W.J. POLLOCK**

APRIL 1991

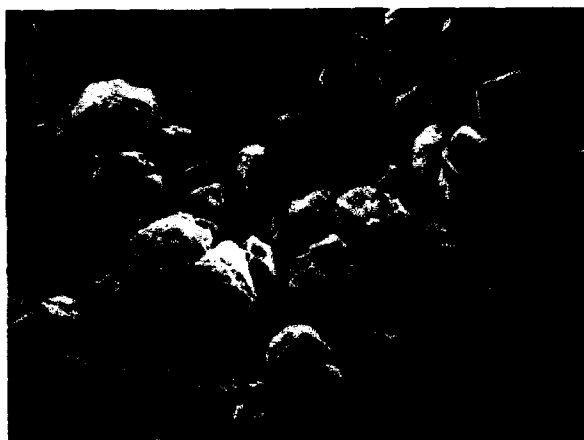
**Figure 6:** Higher magnification micrograph of surface in Figure 5.

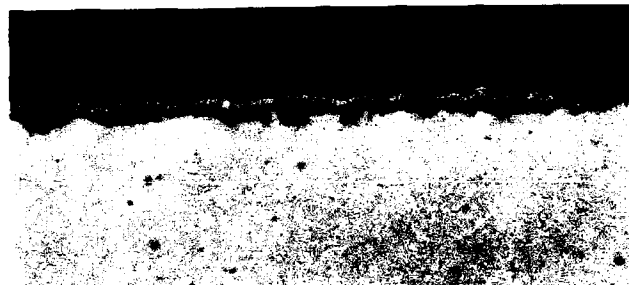
Figure 9 (b): Metallographic section through the IVD coating on an as-deposited MD sheet sample.  
MAG: X200

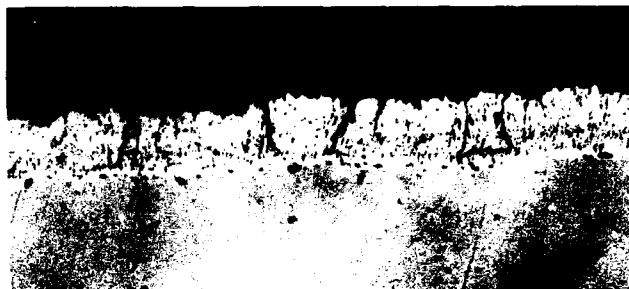
Figure 10 (b): Metallographic section through an IVD coating (I + B + 3I) on a HD sheet sample. Note the porosity free layer adjacent to the steel substrate. MAG: X320

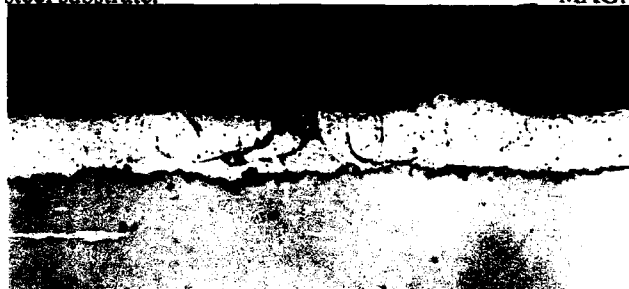
Figure 10 (c): Metallographic section through an IVD coating I + B + 3I + B on a HD sheet sample. Note the almost complete absence of microporosity. MAG: X320

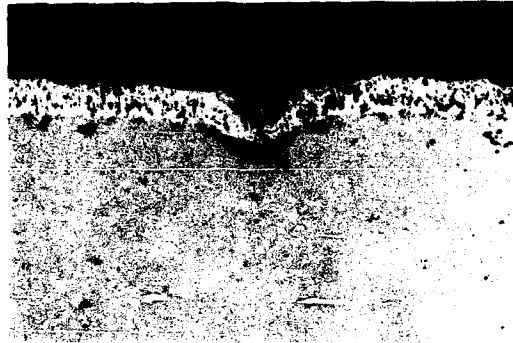
Figure 12: Metallographic section through a surface depression on a glass-bead-blasted HD sheet sample. Note the surface contamination immediately beneath the depression (A). MAG: X400

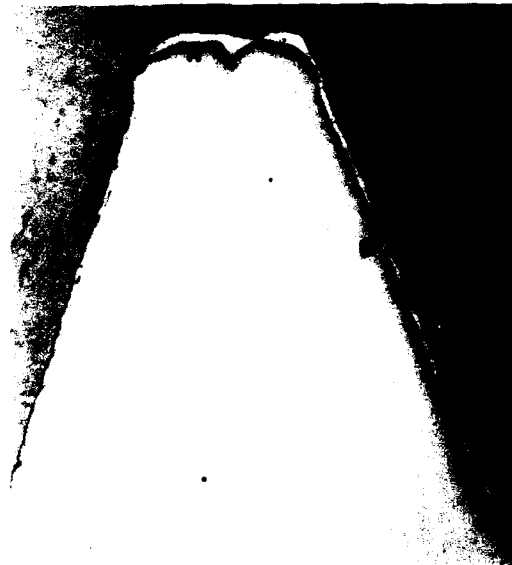
Figure 13: Metallographic section through a single thread of an aircraft bolt showing the variation in IVD coating thickness between the thread crest (A), surface (B) and root (C). MAG: X128

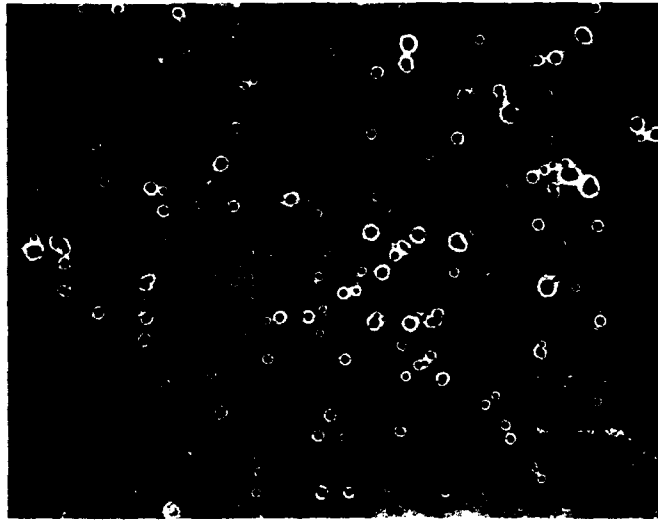
After a few weeks of exposure, pitting was more extensive on the non-glass-beaded IVD surfaces (Figure 16) than on beaded surfaces. With time, a crater of corrosion product forms around the pits and, using a low power stereomicroscope, iron rust is detected within many of the pits (Figure 17). This rust forms as the aluminium loses its effectiveness to act as a sacrificial anode. Precipitation of the aluminium hydroxide polarizes the aluminium coating thus reducing the available galvanic current. This current is then insufficient to provide cathodic protection for the steel substrate. Metallographic sections through pitted specimens showed that aluminium dissolved radially at pores and also along the substrate/aluminium interface where the galvanic driving force is high (Figure 18). On coating surfaces where pitting was not widespread, e.g. those which had undergone two separate periods of glass-bead blasting, only general corrosion of the aluminium was observed as the tests progressed (Figure 19).

Figure 16: Optical micrograph showing extensive pitting on the surface of an as-deposited IVD-coated HD sheet sample. MAG: X4

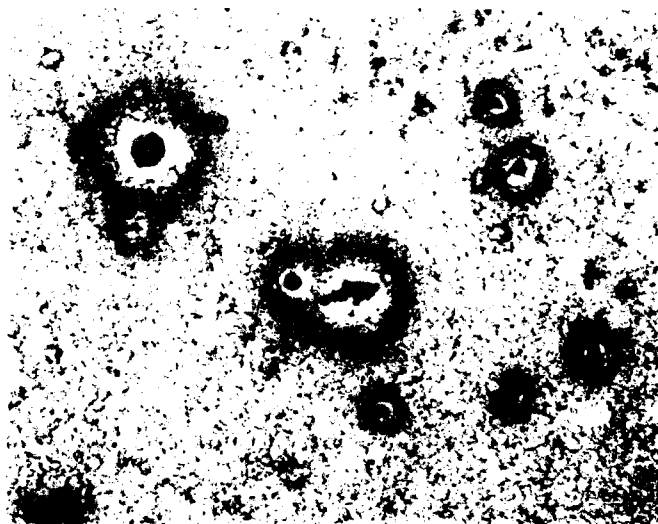
Figure 17: Optical micrograph showing rusting of the steel at the base of pits. MAG: X10

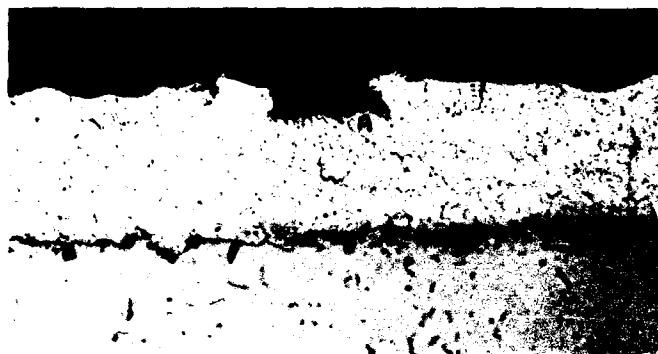
Figure 19: Metallographic section through general corrosion (A) on the IVD coating. MAG: X500

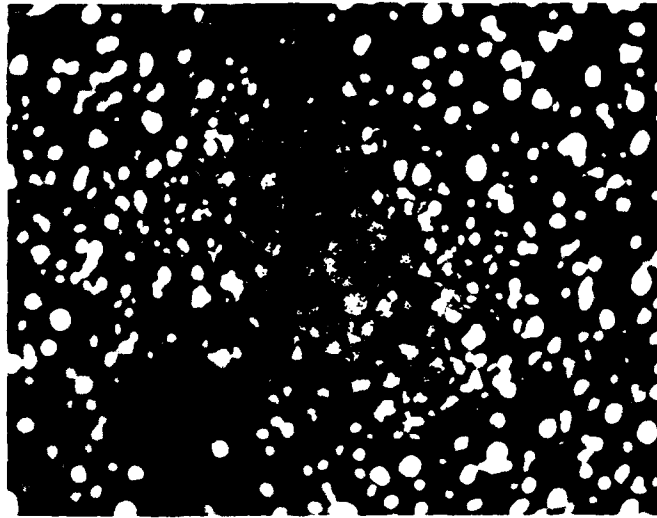
After long exposure times, blisters were detected on the specimen surfaces, particularly on those which had been blasted with glass beads (Figure 20). Some blisters contained a brownish liquid, very likely coloured by rust. Some contained only white corrosion product; others a combination of the two. Other blisters contained only clear liquid. The surfaces of the blisters were very thin and not all of them exposed the underlying steel substrate. It appears that, as corrosion proceeds within pores, either along the substrate/coating interface or between IVD layers, the formation of corrosion product and/or the evolution of hydrogen is sufficient to blister the IVD layers. The general dissolution of the outer IVD surface and its further thinning by stretching would also assist the blistering process.

Figure 20: Optical micrograph showing a blister (in focus) on a beaded IVD surface (out of focus).  
MAG: X160

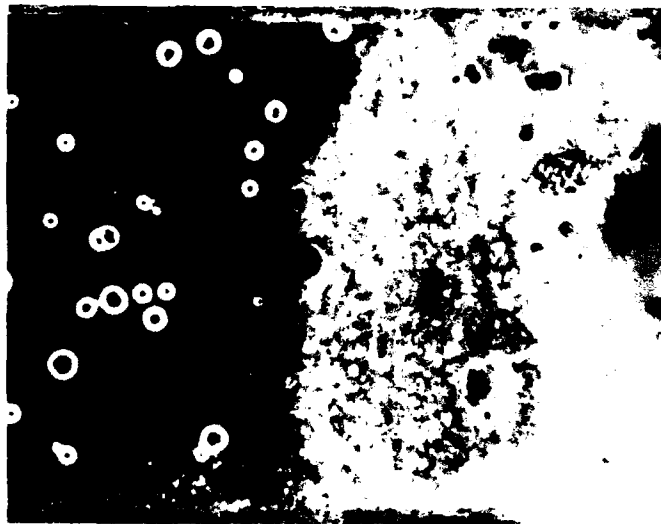
Eventually, with increasing exposure times, red rust stains apparent to the unaided eye developed in the deposits of white corrosion product over pits and within areas of general corrosive attack and blistering (Figure 21). This stage is termed rust bleed-out. The appearance of bleed-out was usually non-uniform on the IVD surface. However, with time, the rust stain became widespread (Figure 22). Despite appearances, some aluminium was still present on the surface at this stage. However, it was very thin, fragmented and only locally adherent.

Figure 21: An as-deposited IVD surface showing "bleed out" of rust stain.  
MAG: x8.5

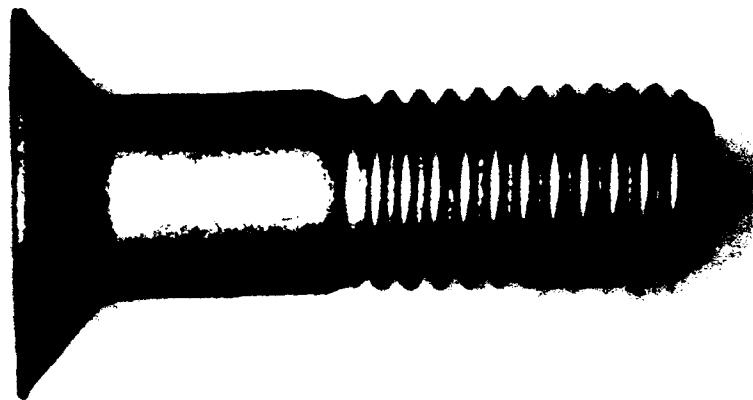
The corrosion behaviour of the IVD coating on the steel bolts, tested under constant immersion conditions, was quite different from that occurring in the IVD coated sheet steel. Pitting did not occur and breakdown was a result of general corrosion of the IVD layer. This occurred firstly within the threads and along the edges of the countersink head, Figure 25. Corrosion then spread along the remainder of the bolt Figure 26. Finally, with the use of low power microscopy, the grey colour of bare steel could be seen. Rusting of the bare steel quickly followed after the IVD layer on the bolt shank and head also thinned and perforated. General rusting of the bolts occurred rapidly once this stage had been reached (Figure 27).

Figure 25: Aircraft bolt showing corrosion of IVD-Al coating in threads (A).  
MAG: X7

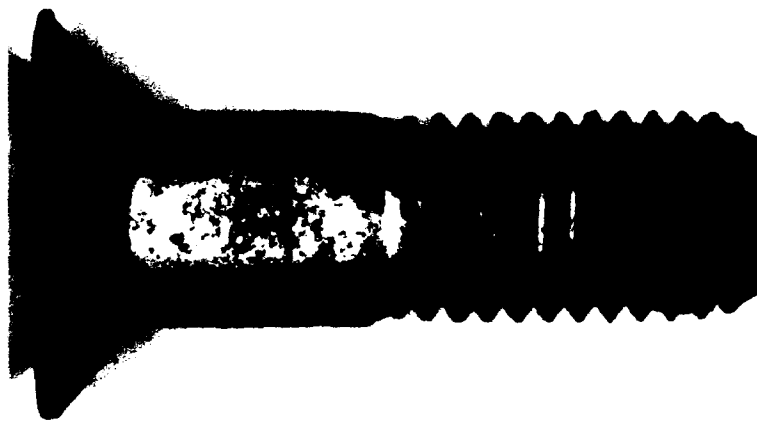
Figure 26: Advanced corrosion of the IVD-Al coating. MAG: X7

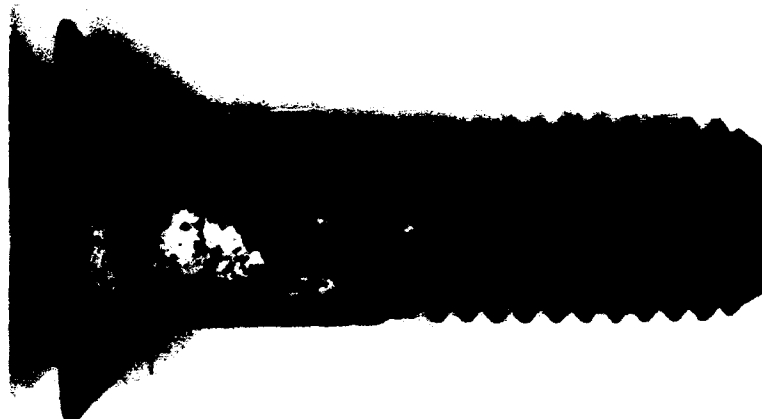
Figure 27: Rust "bleed out" through the showing IVD-Al coating and the almost complete breakdown of coating. MAG: X7

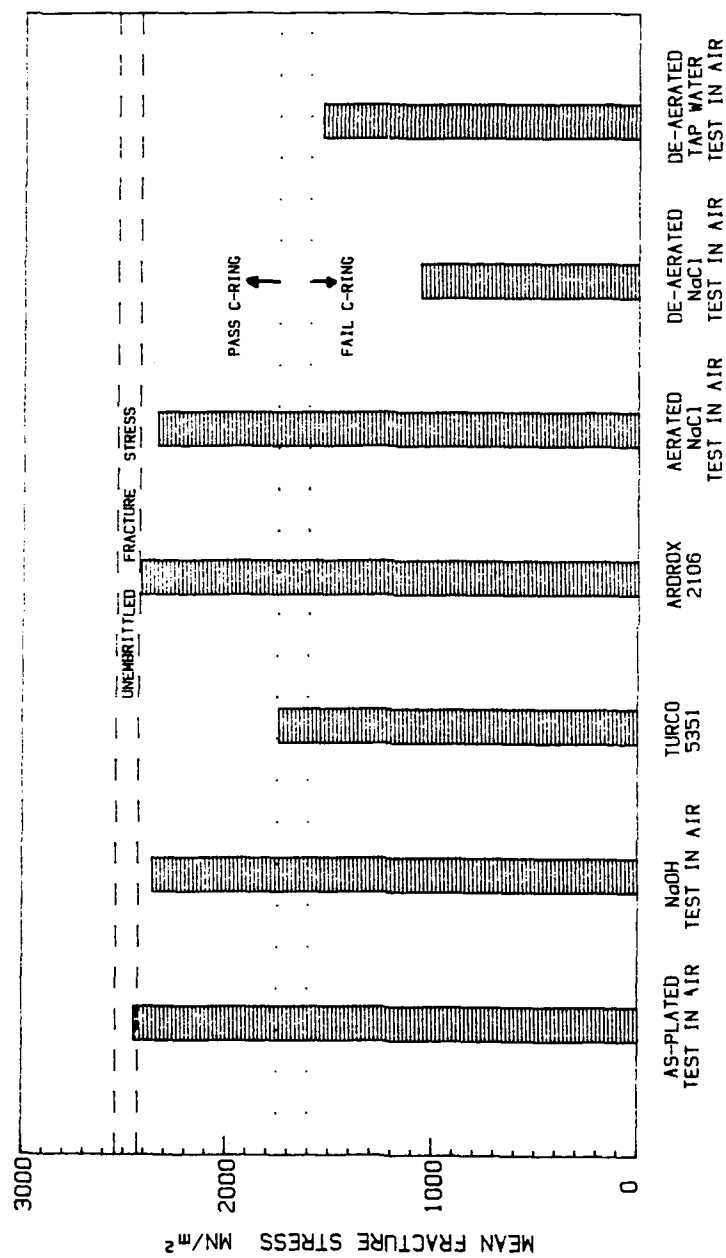
Tests on three IVD coated specimens in Ardrex 2106R paint stripper produced a mean fracture stress of  $2409 \text{ MN/m}^2$  with little scatter, whereas significant embrittlement and substantial scatter were observed when similar tests were conducted using Turco 5351 paint stripper (Figure 28).

The present results confirm that the IVD process itself does not cause hydrogen embrittlement of the steel. Tests conducted with Ardrex 2106 R paint stripper, also showed that this product does not embrittle the steel. In contrast, multiple tests with Turco 5351 paint stripper produced a low mean stress and high standard deviation. This product would come close to causing failure in a standard C-ring test. Slow strain rate tests of notched tensile specimens tested in air, after removal of the IVD coating in 2.5 N sodium hydroxide, indicate a small amount of hydrogen embrittlement. This could be removed by baking at 190°C for 23h. A similar degree of embrittlement was also experienced, when IVD-plated 4340 steel specimens were exposed to aerated 0.1 M sodium chloride for 200h. However, much greater embrittlement occurred when IVD-coated specimens were exposed, either to de-aerated 0.1 M sodium chloride or to de-aerated tap water. The low fracture stress values indicate that exposure to these environments for only 8 days causes sufficient embrittlement to produce failure in standard C-ring tests. These conditions could readily arise during service, particularly in situations where condensation occurs in occluded areas of structure and ingress of air is limited (e.g. crevices, fastener holes, etc). IVD-Al coating, in its present form, should not be used on ultra-high strength steel components in situations where the above condition can develop during service.

Figure 28: Mean fracture stress of Al-IVD plated 4340 steel notched tensile specimens subjected to various environments and tested at a crosshead displacement rate of  $2 \times 10^{-4}$  mm/s

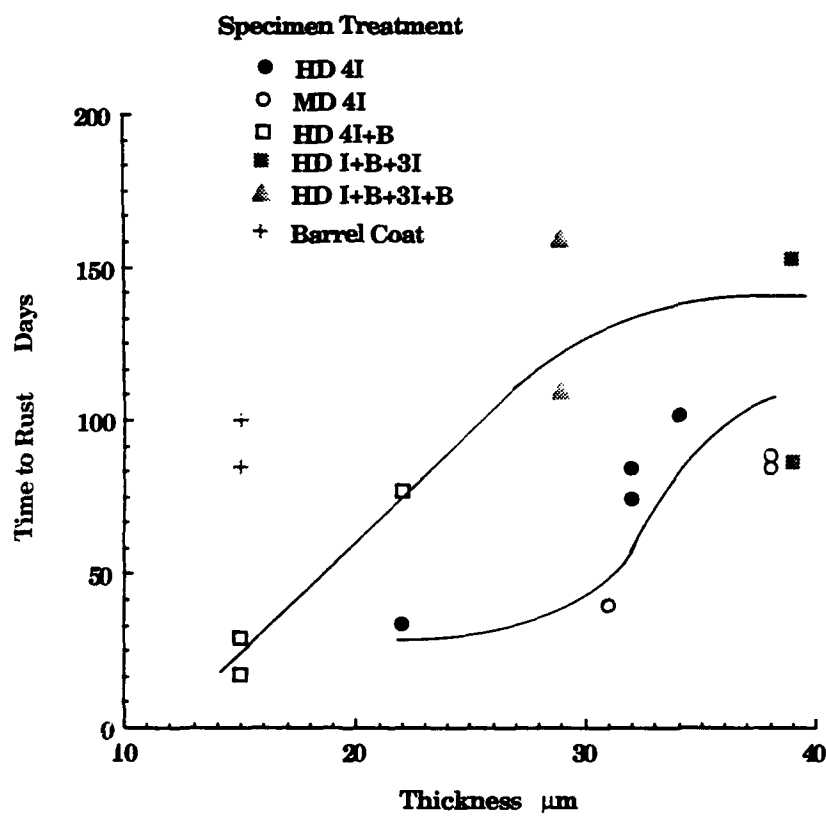
Figure 32: Time to rust, as determined by visual inspection, as a function of coating thickness, for specimens tested under constant immersion conditions.
